Beyond the Pits: Avoiding Costly Downtime Using Novocoat[™] Metal Repair Products

August 2019

OPERATION Asphalt Emulsion Mixing Tank

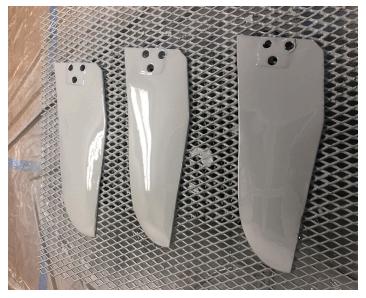
3. Mixing blades coated with Novocoat SC3300 Novolac Epoxy Lining.

Two coats of Novocoat SC3300 Novolac Epoxy Lining were then applied to the blades and the interior of the tank, with a sheet of 1.5 oz chopped strand fiberglass embedded in between coats of the tank lining. Novocoat SC3300 is a solvent free, 100% solids novolac epoxy lining that possesses a low permeation rate, which is ideally suited for internal tank lining due to superior chemical and heat resistance in immersion service.

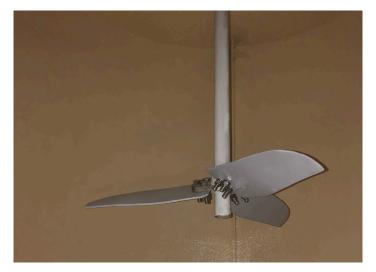
4. Finished interior of mixing tank with restored mixing blades.

The tank became operational approximately one month after completion of the work in August 2019, which was much sooner than replacing the tank altogether, and at a lower cost. Two years after completing the tank refurbishment, the tank was reinspected and observed to be mixing asphalt materials flawlessly, with initial examinations indicating that the lining looked brand new.
