Beyond the Pits: Avoiding Costly Downtime Using Novocoat™ Metal Repair Products

Memphis,
Tennessee

August 2019

Asphalt Emulsion
Mixing Tank

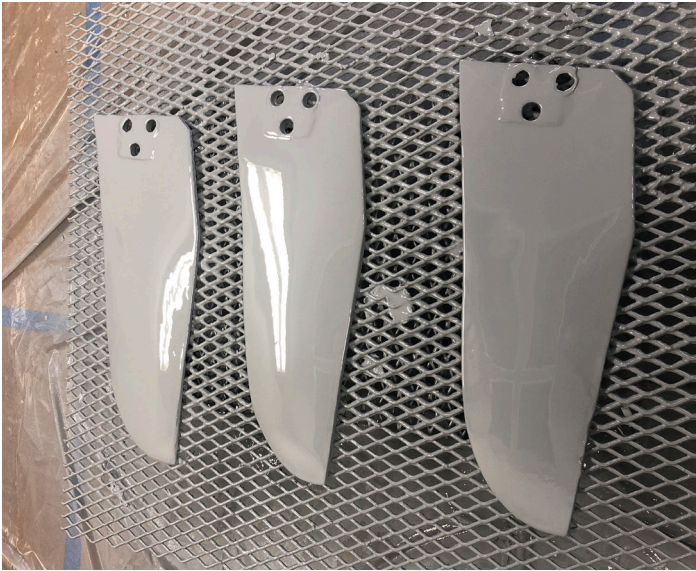
3. Mixing blades coated with Novocoat SC3300 Novolac Epoxy Lining.

Two coats of Novocoat SC3300 Novolac Epoxy Lining were then applied to the blades and the interior of the tank, with a sheet of 1.5 oz chopped strand fiberglass embedded in between coats of the tank lining. Novocoat SC3300 is a solvent free, 100% solids novolac epoxy lining that possesses a low permeation rate, which is ideally suited for internal tank lining due to superior chemical and heat resistance in immersion service.

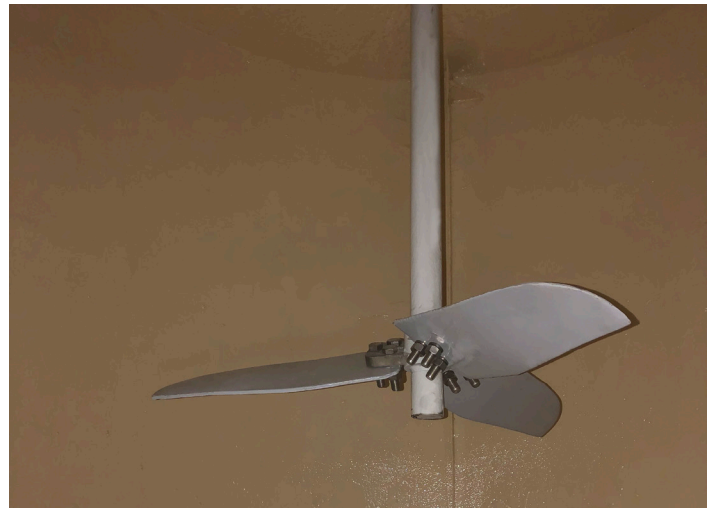
4. Finished interior of mixing tank with restored mixing blades.

The tank became operational approximately one month after completion of the work in August 2019, which was much sooner than replacing the tank altogether, and at a lower cost. Two years after completing the tank refurbishment, the tank was reinspected and observed to be mixing asphalt materials flawlessly, with initial examinations indicating that the lining looked brand new.
