# Relining of Kraft Pulp Mill Chimney Ends Failures in Corrosive Environment

Everett,  
Washington

**Challenge:** Replacement chimney liner needed given increased corrosion protection demands

**Solution:** PENNGUARD Block Lining System over reinforced gunite used as parging material

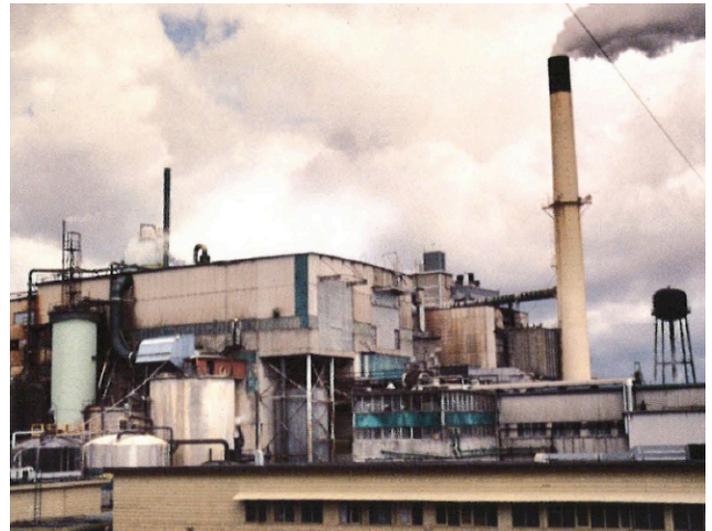
Because of the difference in material properties—primarily expansion coefficients, the FRP lining eventually cracked. Coupled with this was a loss of bonding between the bricks and mortar which allowed corrosive moisture to penetrate the liner system and damage the concrete chimney shell.

In the Fall of 1982, Custodis was awarded a contract to remove the FRP/brick liner and replace it with a lining of closed cellular foamed borosilicate glass block (ErgonArmor's PENNGUARD Block), a lightweight, totally inorganic material that is highly resistant to high-temperature flue gasses as well as acidic flue gas condensates.

The lining was removed, the corbels inside the chimney were cut out, and the concrete cleaned and then restored with a 2 inch reinforced gunite liner, troweled to a continuous, uniform surface.

Custodis used nearly ten thousand square feet of PENNGUARD Blocks, each 6 inch x 18 inch, bonding them directly to the applied gunite lining with a 1/8 inch thick layer of an acid-resistant urethane asphalt adhesive membrane (PENNGUARD Adhesive/Membrane). A 2½ inch thick block used in the lower portion of the chimney insulated the adhesive membrane from the higher temperatures in that area; 2 inch thick block was used in the remainder of the column.
