# Steel producer repeats unique corrosion solution for multi-acid containment area

**Challenge:** Protect concrete floors, trenches and perimeter curbing against multiple corrosive acids and fumes at a cost-effective price point

**Solution:** Graphite tiling system using TUFCEM II Membrane over PENNTROWEL Epoxy Primer and FURALAC Green Panel Mortar for the bed and side joints

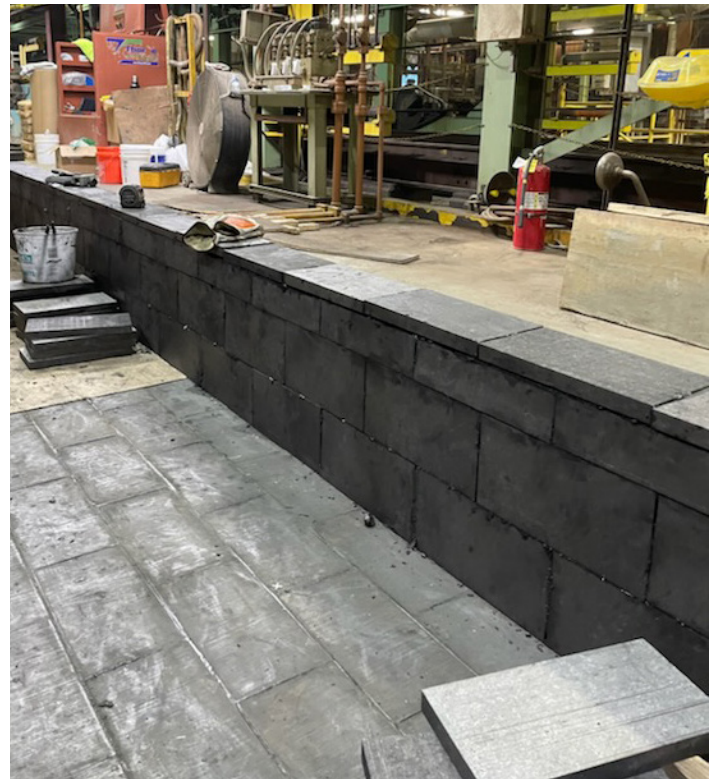
*Tile Installation – Graphite tile on floor and curbing*

In the new area, PENNTROWEL Epoxy Primer was applied first to seal the concrete. This important step prevents outgassing from causing blisters or pinholes in the membrane. Next, a 1/8-inch layer of TUFCEM II Membrane was troweled over the primer to provide a flexible chemical barrier under the tile. Last, the graphite tile was installed over the membrane with FURALAC Green Panel Mortar in the side, head, and bed joints.
